# Exterior Restoration of the **OLD GUILFORD COUNTY COURTHOUSE**

## **ASSESSMENT AND RECOMMENDATIONS**

November 9, 2016

Prepared for  
Robert McNiece, Director  
Facilities and Parks  
Guilford County

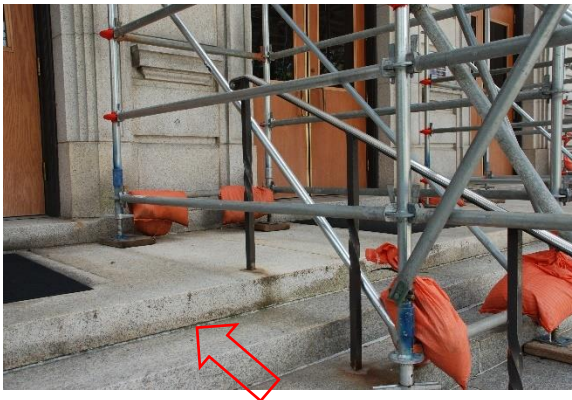
*The entrance steps and flanking walls on the north and east facades have many open joints that need to be raked and repointed as well. Note the failing mortar joint at the base of the top step in the photo, which is typical of other areas.*

*Low stone walls surround the lawn areas on the north and east sides of the building and are also in need of repair. Many of the slab caps need to be reset as they are loose and not in proper alignment.*

1. Joint replacement (walls, decorative features, and entrance steps)
  - Rake mortar or sealant from joints, to a depth of 1", or depth of deterioration, whichever is greater.

- Repair cracked granite with injected resins.
3. Landscape walls surrounding the north and east lawns: Reset top caps with pins and mortar, repair walls and clean.

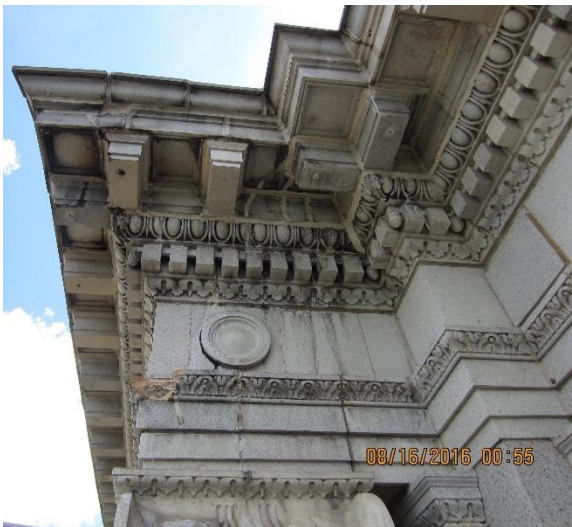
*From close observation and investigation, most of the terra cotta and its steel anchoring systems appears to be in very good condition.*

*The condition of the terra cotta units varies from excellent to severely deteriorated at limited areas. Units with minor cracks, damaged edges, and spalls that can be repaired in-place, while some pieces will require replacement.*

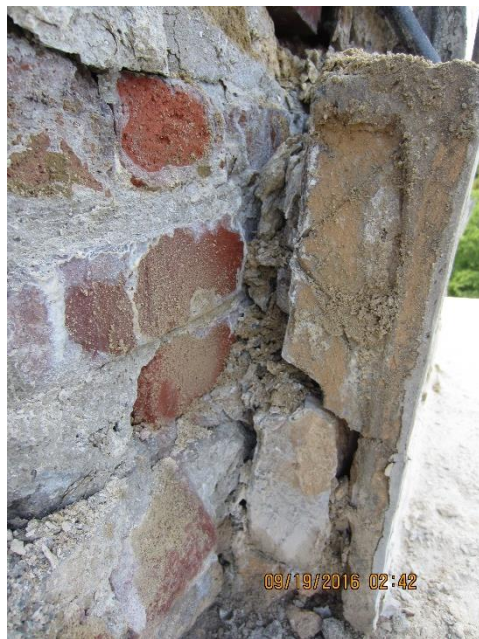
*The cracked terra cotta unit to the right is the same unit that is marked "I" in the previous photo. Moisture in the structure has caused expansion and contraction with freeze thaw cycles that has split the terra cotta.*

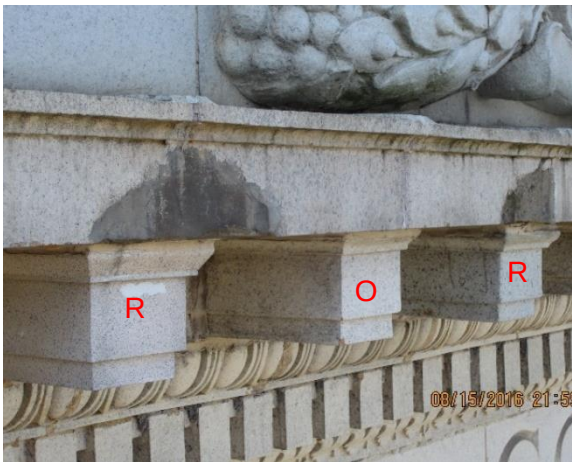
*Under the cornice at the base of the parapet wall, decorative modillions hang on steel hooks. Due to water infiltration, many of these modillions are damaged and approximately 77 of a total of 328 modillions were previously replaced with fiberglass units attached with wood nailers. In addition, a number of original modillions are not in good condition and need repairs.*

*R marks previously replaced modillions and O marks an original one still in place. Note the spalled face of the terra cotta above the replaced units.*

- Replace with manufactured terra cotta units matching the size, profile, and finish of existing matching units.
  - Replace previously replaced and deteriorated modillions.
