Exterior Restoration of the **OLD GUILFORD COUNTY COURTHOUSE**

Greensboro, North Carolina

ASSESSMENT AND RECOMMENDATIONS

November 9, 2016

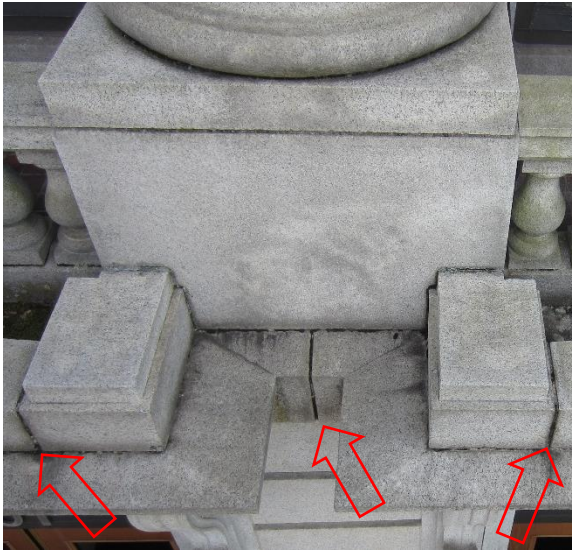
Most of the granite is in excellent condition with a limited number of spalls and cracks including two window lintels. Mortar joints are in poor condition with hairline cracks that could allow moisture to enter the walls if not corrected. These have been repointed three or four times and the mortar is not consistent in composition or color. Other joints that are more open to the weather have completely failed.

Based on sample areas, the depth of joint deterioration on the walls is limited while skyward facing joints are in worse condition, with many areas of missing mortar or sealant.

1. Joint replacement (walls, decorative features, and entrance steps)
 - Rake mortar or sealant from joints, to a depth of 1", or depth of deterioration, whichever is greater.

2. Repair stone
 - Loose small shards shall be removed, cleaned and epoxied back into place.
 - Spalls shall be tooled to remove distinctive edges or repaired with granite Dutchman patches.

- Repair cracked granite with injected resins.
3. Landscape walls surrounding the north and east lawns: Reset top caps with pins and mortar, repair walls and clean.

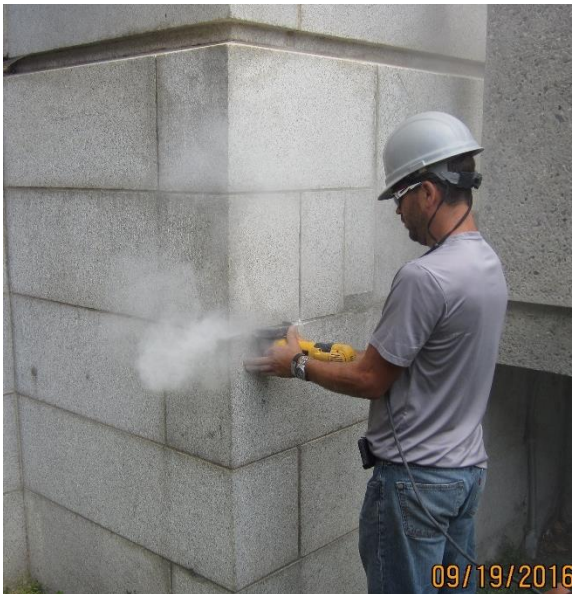
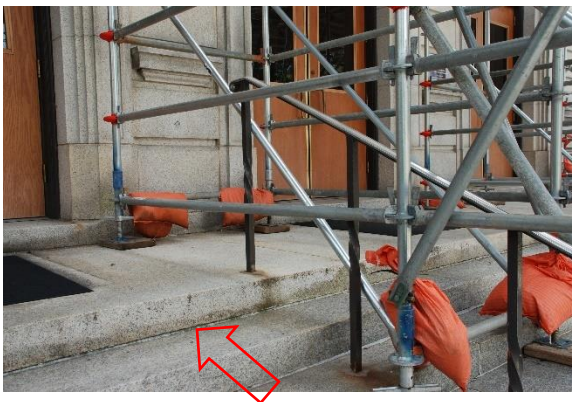
The entrance steps and flanking walls on the north and east facades have many open joints that need to be raked and repointed as well. Note the failing mortar joint at the base of the top step in the photo, which is typical of other areas.

Low stone walls surround the lawn areas on the north and east sides of the building and are also in need of repair. Many of the slab caps need to be reset as they are loose and not in proper alignment.

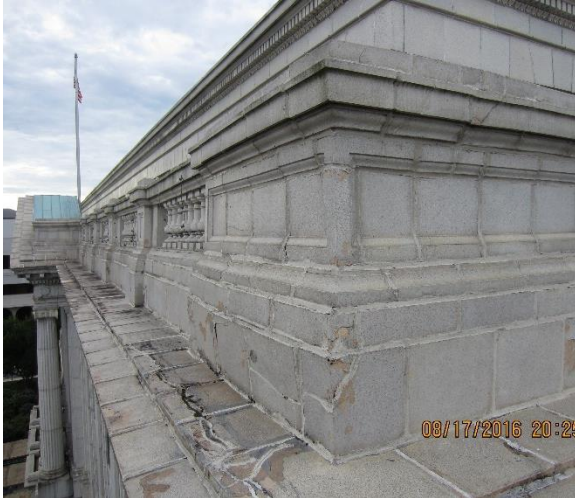
Approximately 35 linear feet of the north parapet wall has failed due to water infiltration through open joints and the effect of expansion and contraction during freeze/thaw cycle. This area has severe to moderate damage, with the most damage at the western end. (This 35 foot section is 7% of the total length of 494 linear feet.)

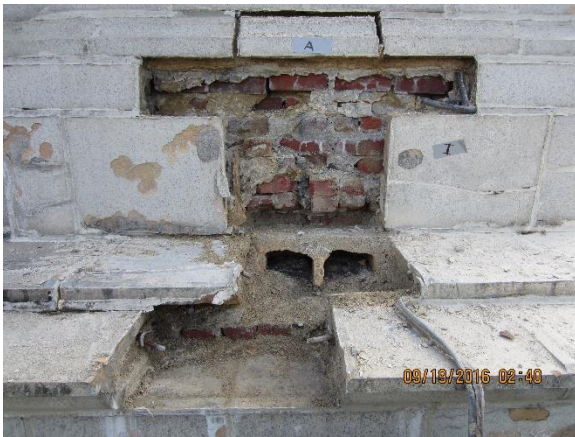
The area of terra cotta, shown in the picture above, was opened to investigate the interior of the terra cotta clad parapet. The interior of the wall was very wet and many of the terra cotta units were quite deteriorated. Despite the condition of the terra cotta cladding, the wall itself is structurally sound and the terra cotta can be repaired or replaced.

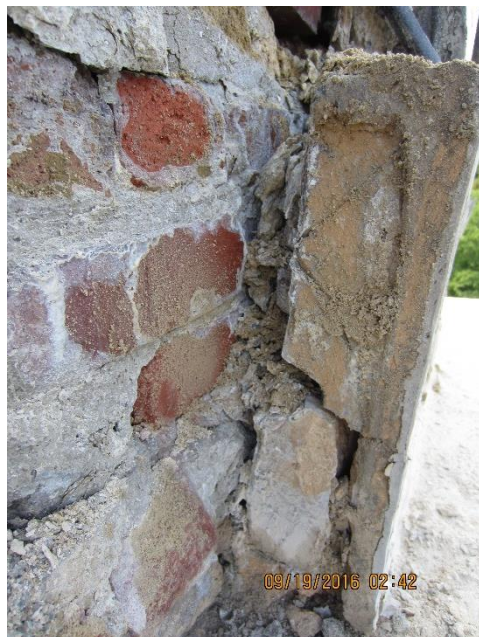
The cracked terra cotta unit to the right is the same unit that is marked "I" in the previous photo. Moisture in the structure has caused expansion and contraction with freeze thaw cycles that has split the terra cotta.

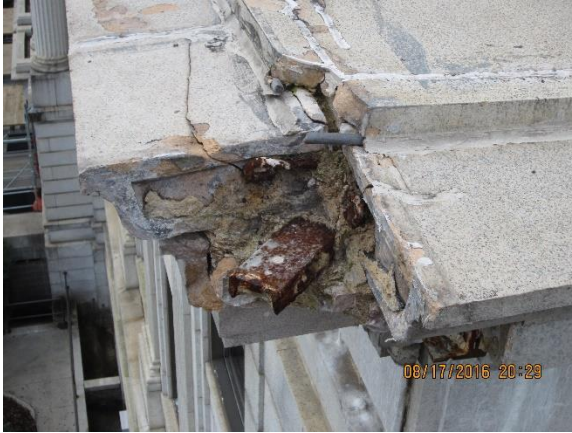
Northwest corner of the cornice with missing terra cotta, leaving some of the interior steel supports and anchors exposed. The metal that was exposed during investigation was corroded (rusted), but there was not significant loss of material. The steel can be treated and left in place without additional support added.

9. Anchors and Hangers
- Replace any severely deteriorated or missing anchors and hangers with galvanized steel that are exposed during the work.
 - Remove corrosion of any exposed steel to clean metal, treat with corrosion inhibitor, and paint with corrosion resistant epoxy paint.

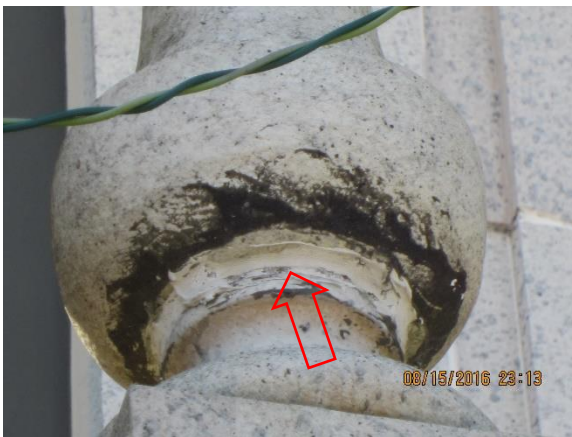
Joints are in poor condition and many have been filled with copious quantities of poorly installed sealant that is failing. Some joints have as many as 3 to 4 layers of sealants that were added at various times and there are other joints that have sealant that is not needed.

- Remove mortar or sealant from joints, to a depth of 1", or depth of deterioration, whichever is greater.
- Remove mortar with abrasive wheel and right angle grinder. Remove sealant with knives.
- Extreme care is to be taken for the utmost control to prevent damage to the terra cotta glaze.

- Install new mortar to match existing in color, texture, and compressive strength based on testing of the original mortar.
 - Installation of new mortar shall follow preservation guidelines including post wetting mortar to maintain a moist condition for 48-72 hours.

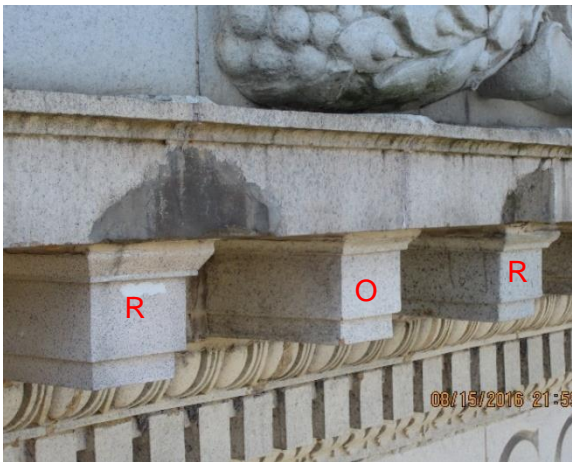
Under the cornice at the base of the parapet wall, decorative modillions hang on steel hooks. Due to water infiltration, many of these modillions are damaged and approximately 77 of a total of 328 modillions were previously replaced with fiberglass units attached with wood nailers. In addition, a number of original modillions are not in good condition and need repairs.

R marks previously replaced modillions and O marks an original one still in place. Note the spalled face of the terra cotta above the replaced units.

- Remove previously replaced fiberglass modillions and their wood anchorage.
 - Establish guidelines for types of repair and replacement based upon the degree of deterioration.

- Replace with manufactured terra cotta units matching the size, profile, and finish of existing matching units.
 - Replace previously replaced and deteriorated modillions.

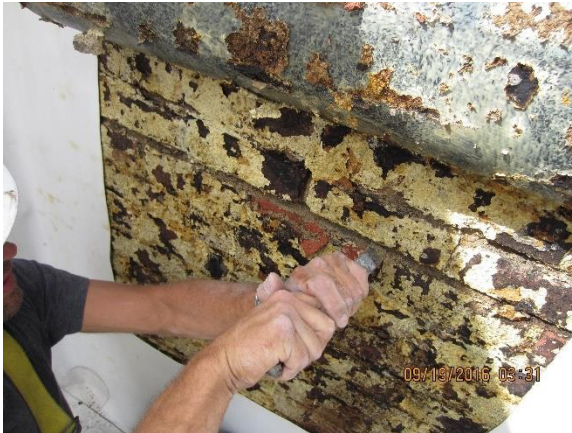
*(See also the section on moisture protection.)
The existing TPO covering on the back of the parapet walls has caused deterioration to the brick. The brick units are in good condition, but the mortar joints have deteriorated to a depth of 2/3 of the joint.*

1. Clean adhesives from the surface: Use a proprietary cleaning system based upon testing and evaluation, using the gentlest means possible.
2. Rake and repoint brick: See descriptions under stone and terra cotta for similar methods.

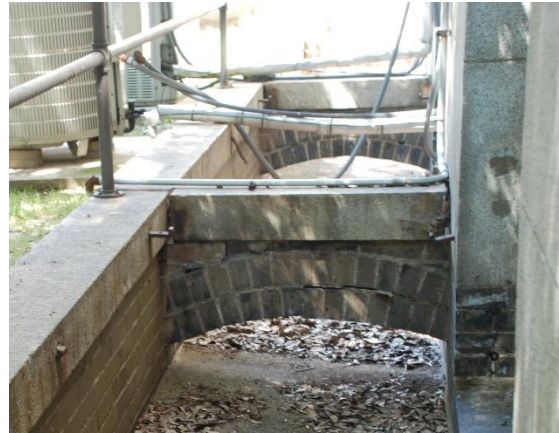
Basement window wells are constructed of brick with stone caps. Most of the brick needs repair.

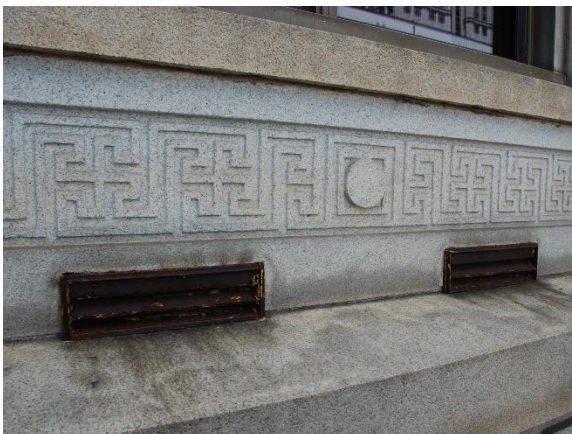
Original cast iron fresh air vents remain on the exterior and are highly corroded and are staining the stone below.

1. Cast iron louvers: Remove, clean, galvanize, paint and reinstall in sealant.
2. Handrails: Repair, clean, prep, and paint.

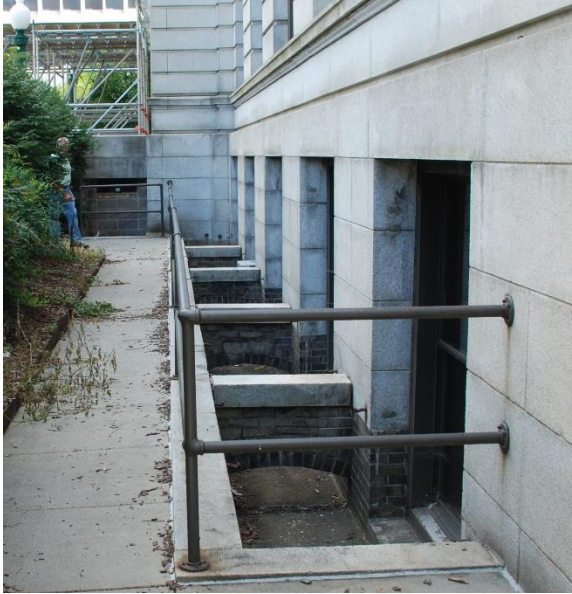
Pipe guardrails at the basement window wells.

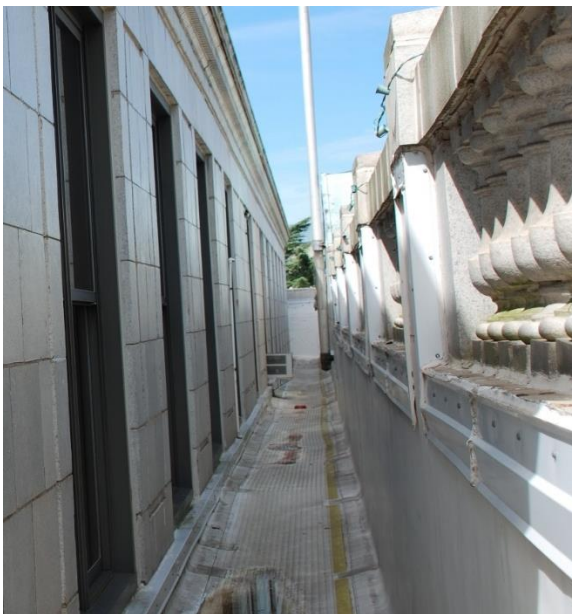
The 4th floor catwalk is covered with a TPO membrane that is generally in good condition, but is creating problems as it extends up the back of the parapet walls and is trapping moisture inside the wall. This moisture is contributing to the deterioration of the parapet. The membrane should to be removed from the wall and the brick should be cleaned of adhesive and repointed.

1. Catwalk membrane
 - Remove membrane and replace after completion of adjacent work
2. Built-in gutter
 - Remove, peel back carefully, extreme outer portion of existing roof membrane to gain access to metal over wood nailer.

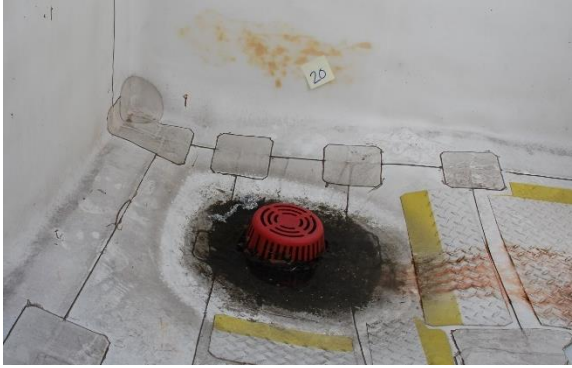
The catwalk has 6 drains - one at each corner and one opposite the pediments at the main entrances. The one at the southeast corner is probably causing water damage to the former courtroom below. Investigation revealed that the drain system includes a 3" diameter pipe from the roof deck that extends into a larger drainage pipe and the two are not sealed. Both the capacity of the smaller pipe and the connection could be allowing water to enter the structure.

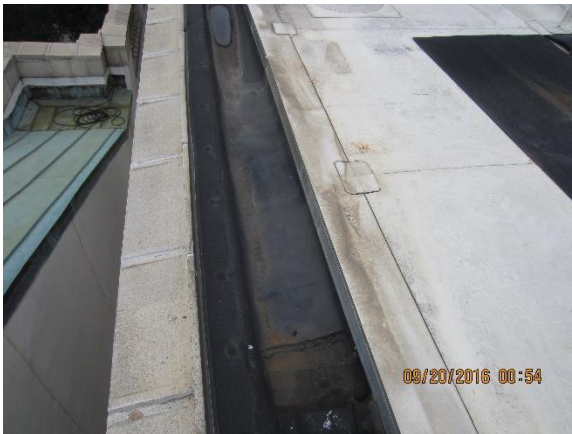
The built-in gutter at the perimeter of the main roof needs to be repaired as it does not properly seal the exterior edge of flashing to the terra cotta underneath it.

- Remove metal flashing to a point that will expose wood and determine if any damage exists requiring repair.
 - Metal is originally designed to come down and cover wood and meet with top edge of masonry.

- Bring flashing metal down to intended location, or replace metal so that it will meet as intended.
 - Seal this joint created when metal is in proper position.

- Replace roofing membrane into proper position and secure.
3. Standing seam copper roof and flashings
 - Remove existing copper roof and flashings at the top of the north and south pediments.

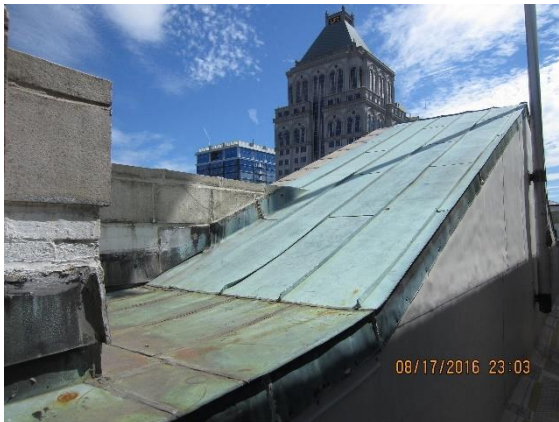
The pediments are covered with copper roofing that is in moderate condition. Considering its condition and adjacent work to the parapets, replacement is recommended.

- Reinstall new copper roofing and flashing with improved detailing for drainage.
4. Balconies
 - Install membrane over existing tile
 - Replace drains and piping

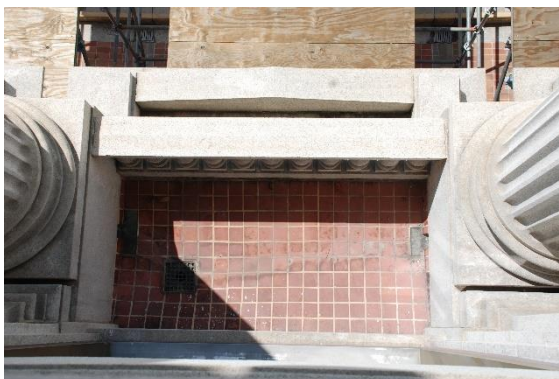
The balconies over the north and south entrances are floored with original clay tile and the outer two areas drain through a scupper to the center area, with a single drain. The ceilings of the vestibules underneath show evidence of long-term water damage. Water testing of the drain on the north side revealed that water is entering the outer stone wall due to open joints and that the drain pipe leaks below the 1st floor level.

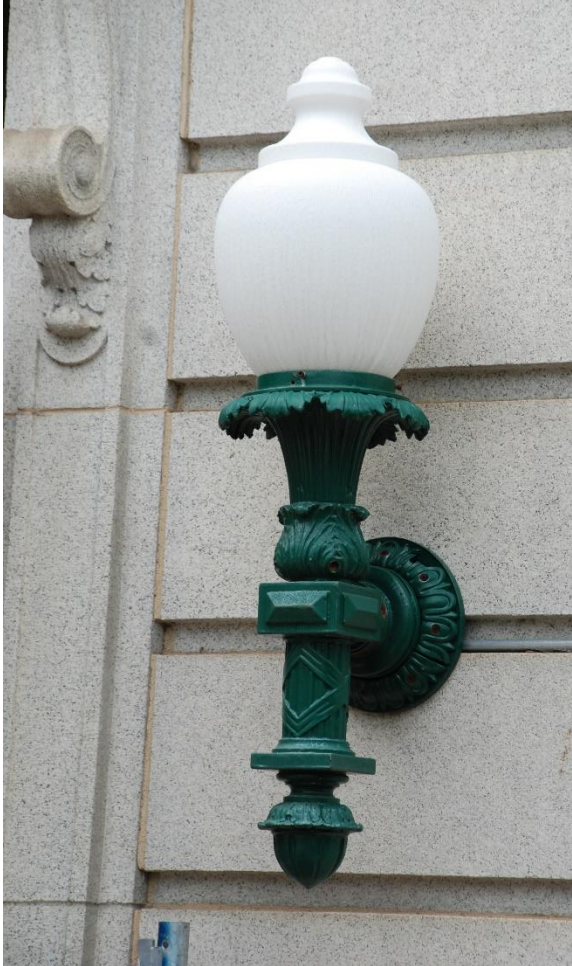
Original wall light from one of the side entrances, now relocated at the South entrance. The globe has been replaced and it was originally painted the same color as the windows and the doors.

- A. Lighting: Replicate wall-hung fixtures and install at the east and west entrances.
- B. Paint existing and new fixtures to match original color.

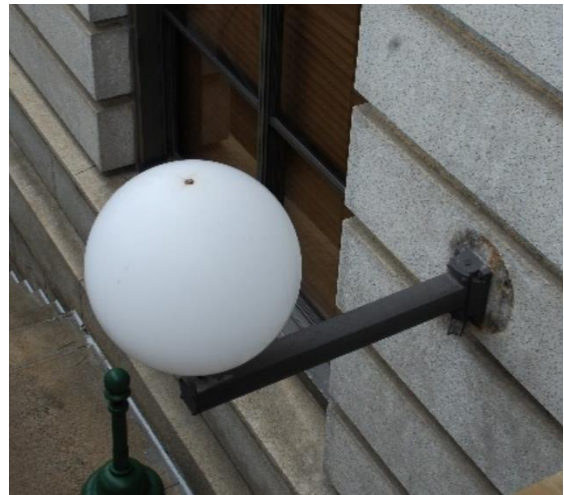
Replacement fixtures currently on the east and west facades.
