Exterior Restoration of the **OLD GUILFORD COUNTY COURTHOUSE**

Greensboro, North Carolina

ASSESSMENT AND RECOMMENDATIONS

November 9, 2016

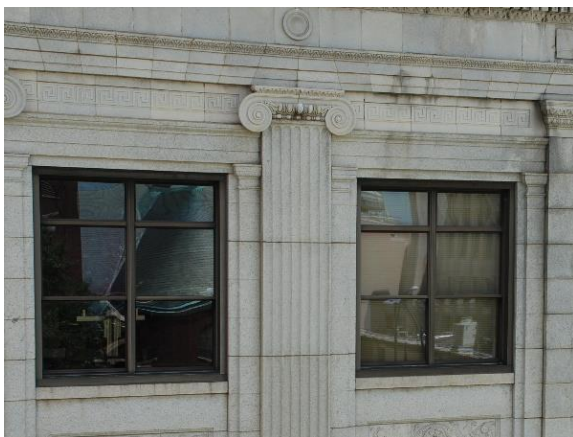
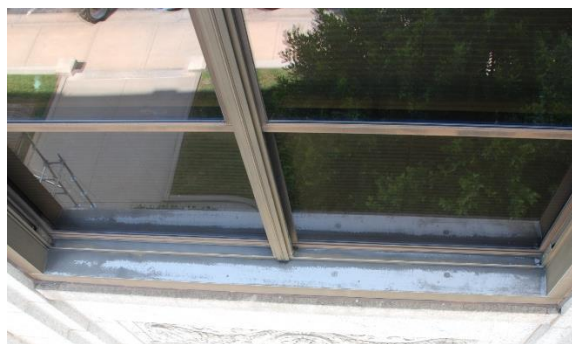
VI. WINDOWS: Original wood austral (tilting) windows were replaced c.1980 with single hung aluminum windows with fixed transoms and insulated glass. The fourth floor windows appear to have been replaced separately from the windows on the lower floors as these vary in detail and were made by different manufacturers. The lower floor windows are by Traco, the upper windows are not labeled.

In addition, these windows do not replicate the original windows in detail and they have changed the overall appearance of the exterior of the building. Other changes to the windows and the exterior of the building include HVAC louvers and units as well as conduit and condensate lines.

Original windows are shown in the historic photographs above and can be compared to the existing windows above.
